Technical Report Series

Three Firefighters Die in Pittsburgh House Fire Pittsburgh, Pennsylvania

Investigated by: J. Gordon Routley

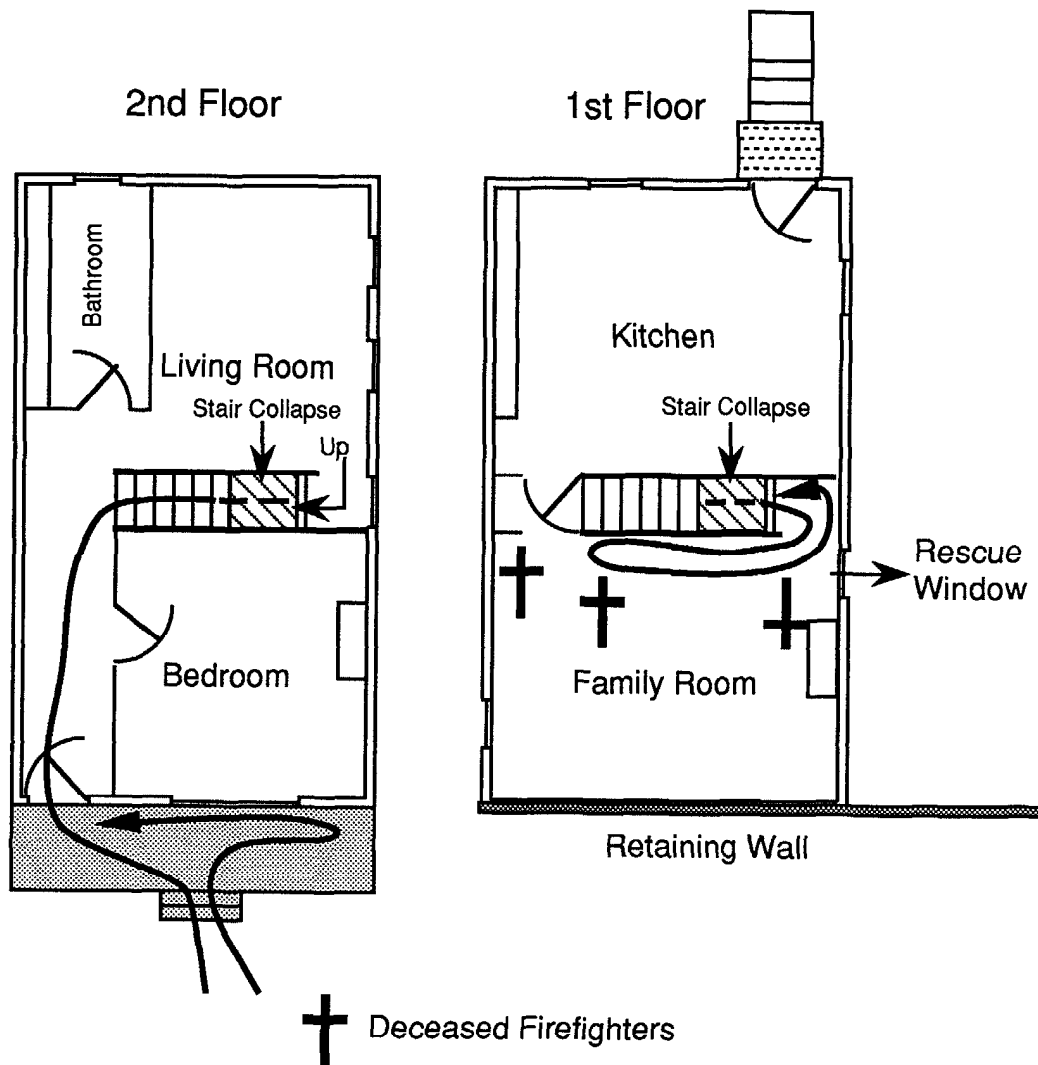
INTERIOR DETAILS - 8361 Bricelyn Street

Advancing into the family room, the crew from Engine 7 found the three unconscious personnel from Engine 17. (See diagram on the following page.) At 0139 hours the Incident Commander was informed that three additional firefighters had been found and were being removed from the building. Additional personnel responded to the urgent requests for assistance and the three firefighters were removed to the rear yard.

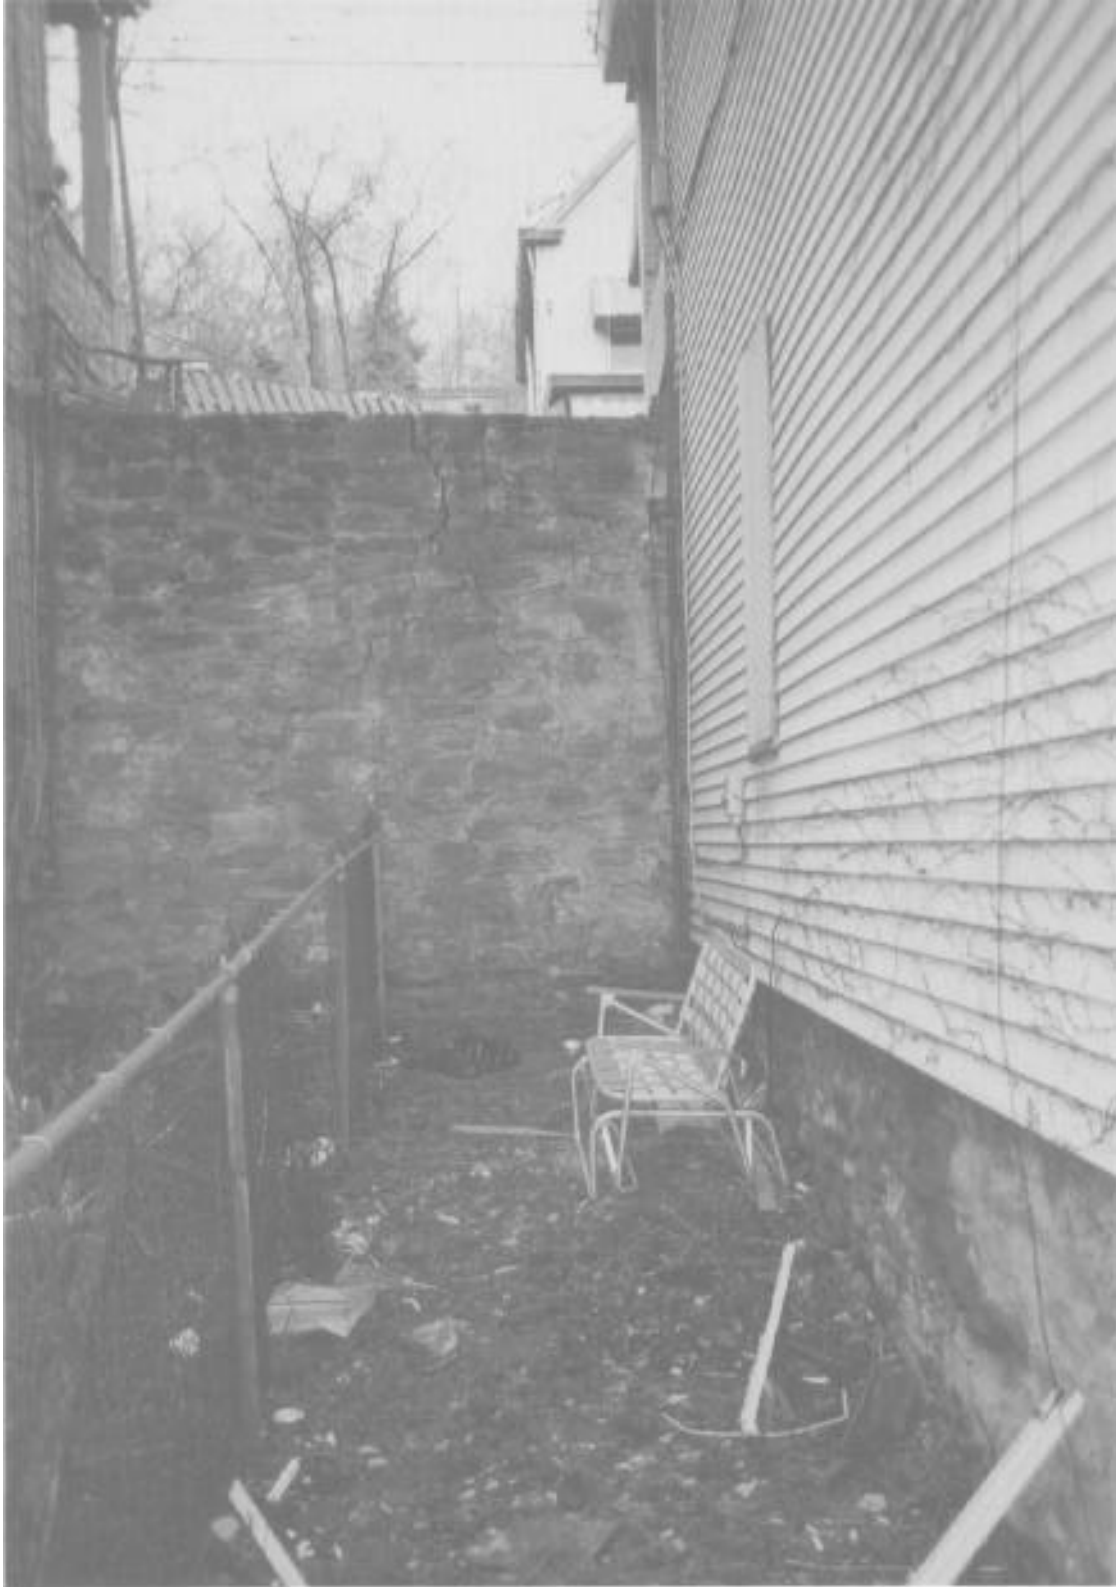
Side yard showing retaining wall and window where firefighters were rescued
(above lawn chair.)

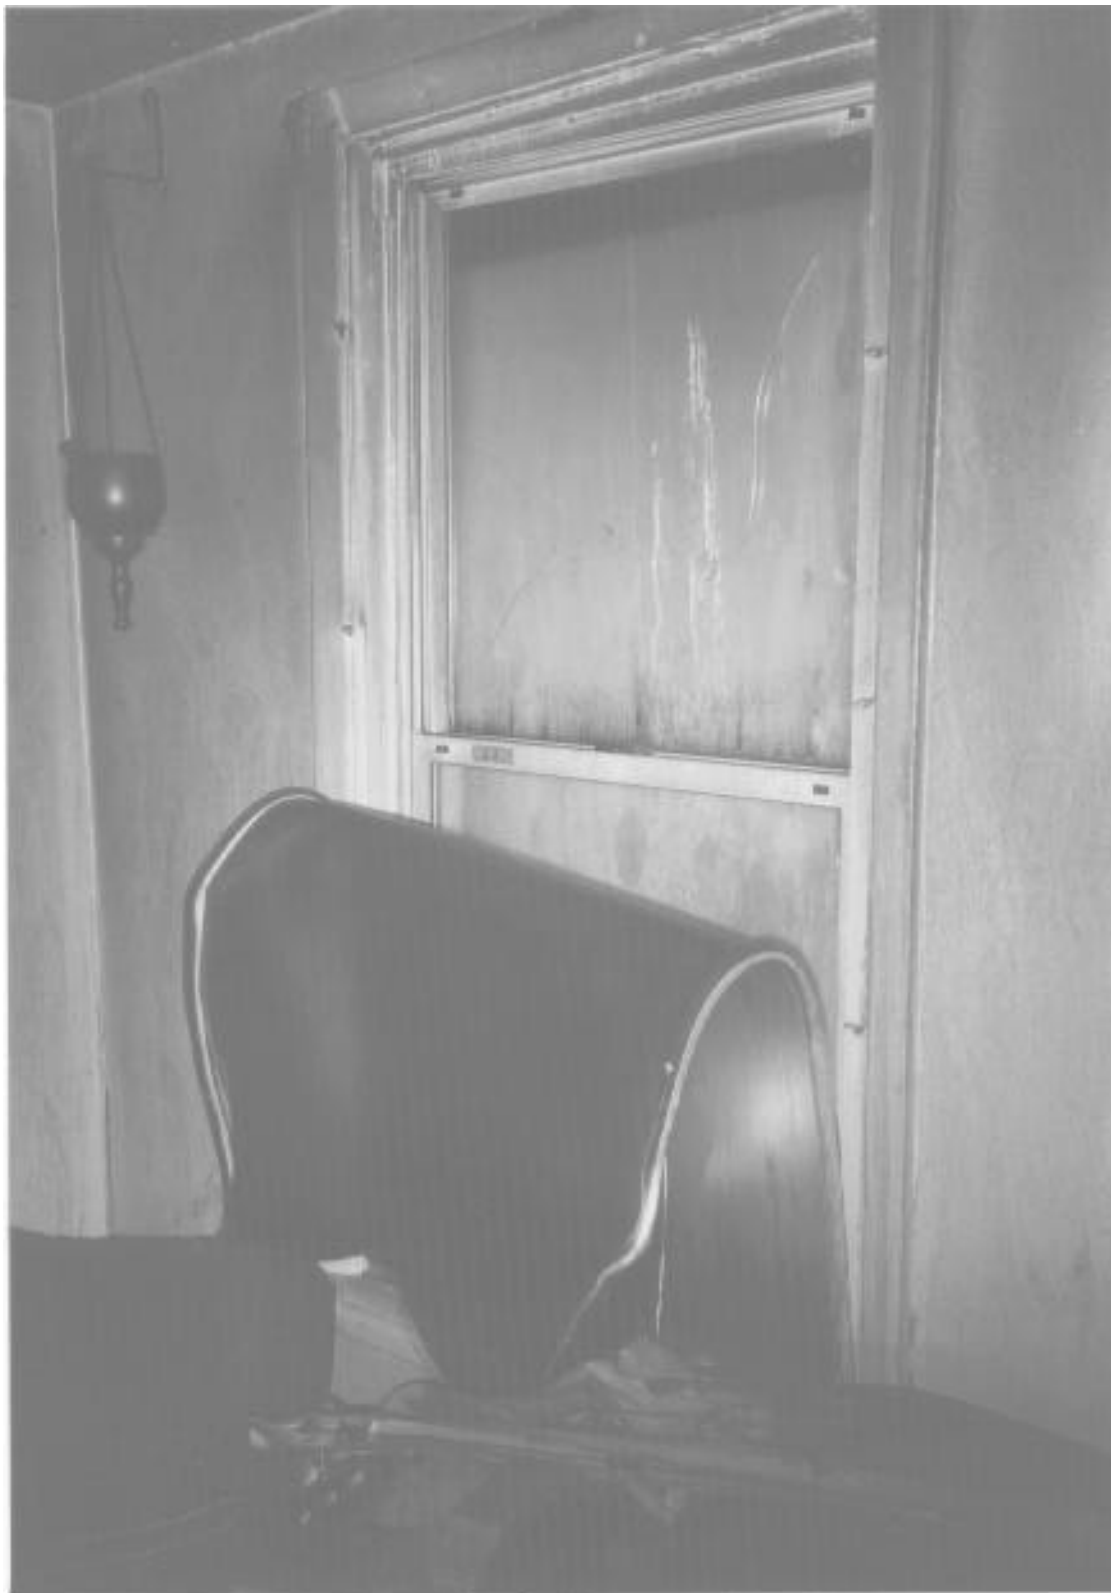
Window in corner of family room showing plastic panel which has partially melted and bent-over due to heat.

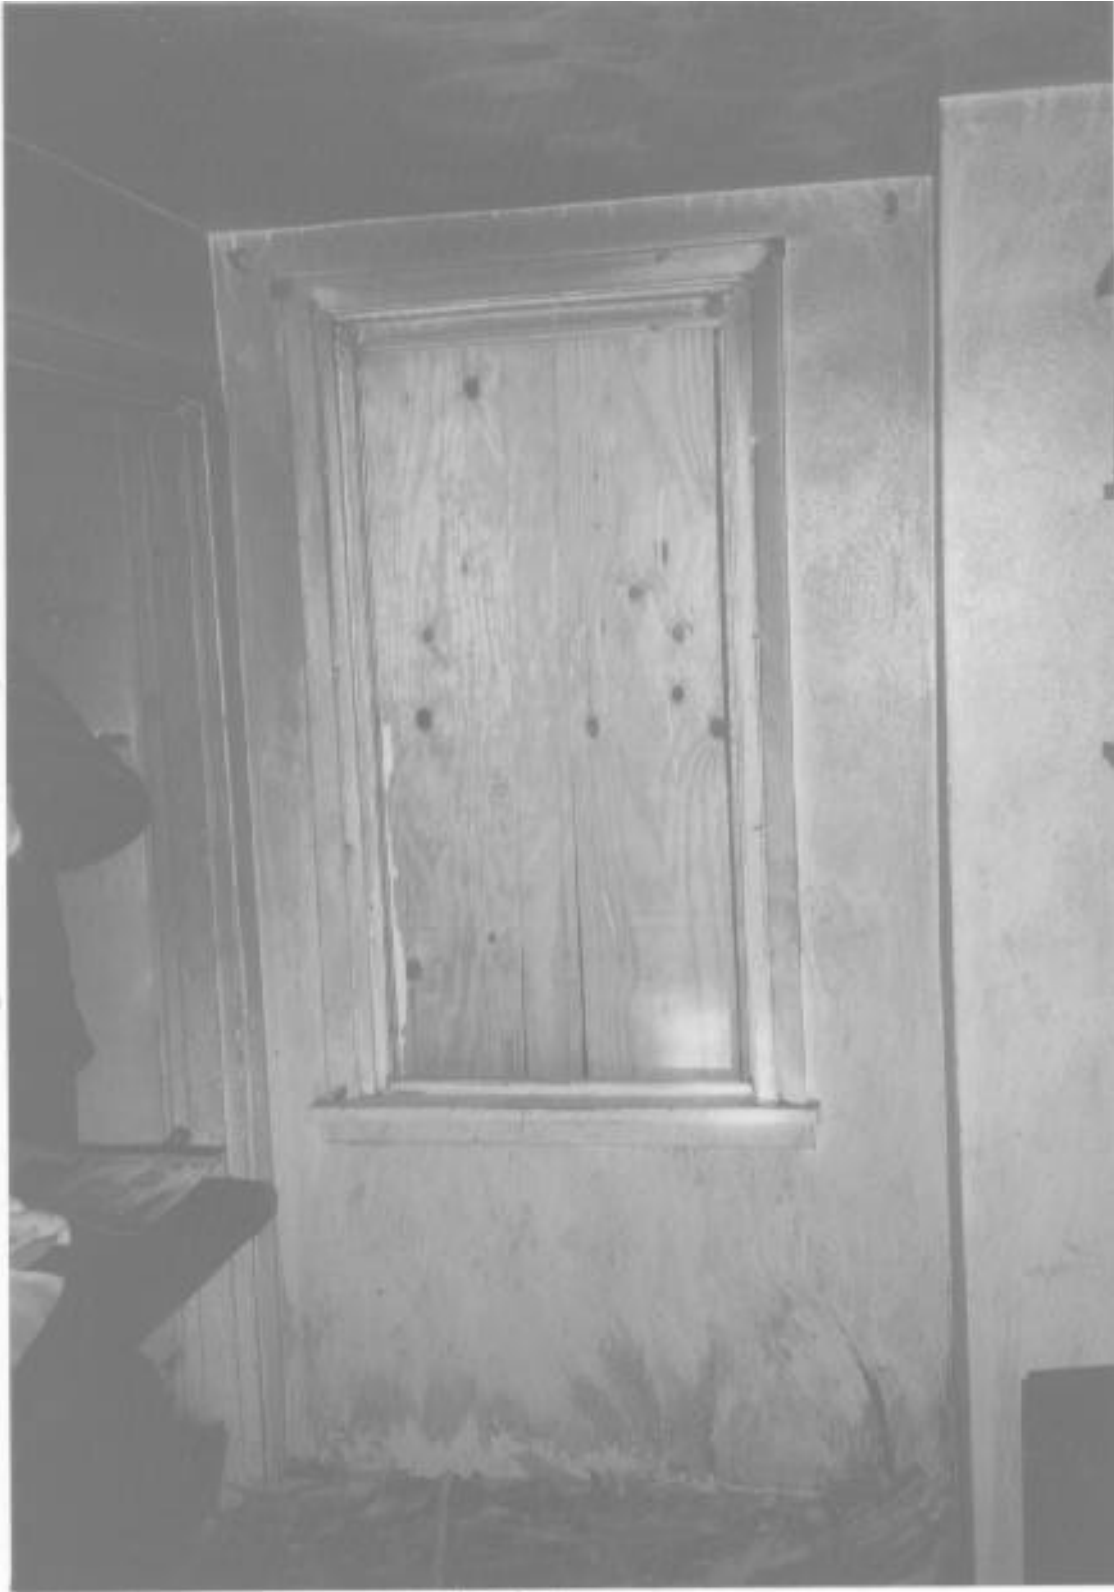
Inside view of window where firefighters were rescued.

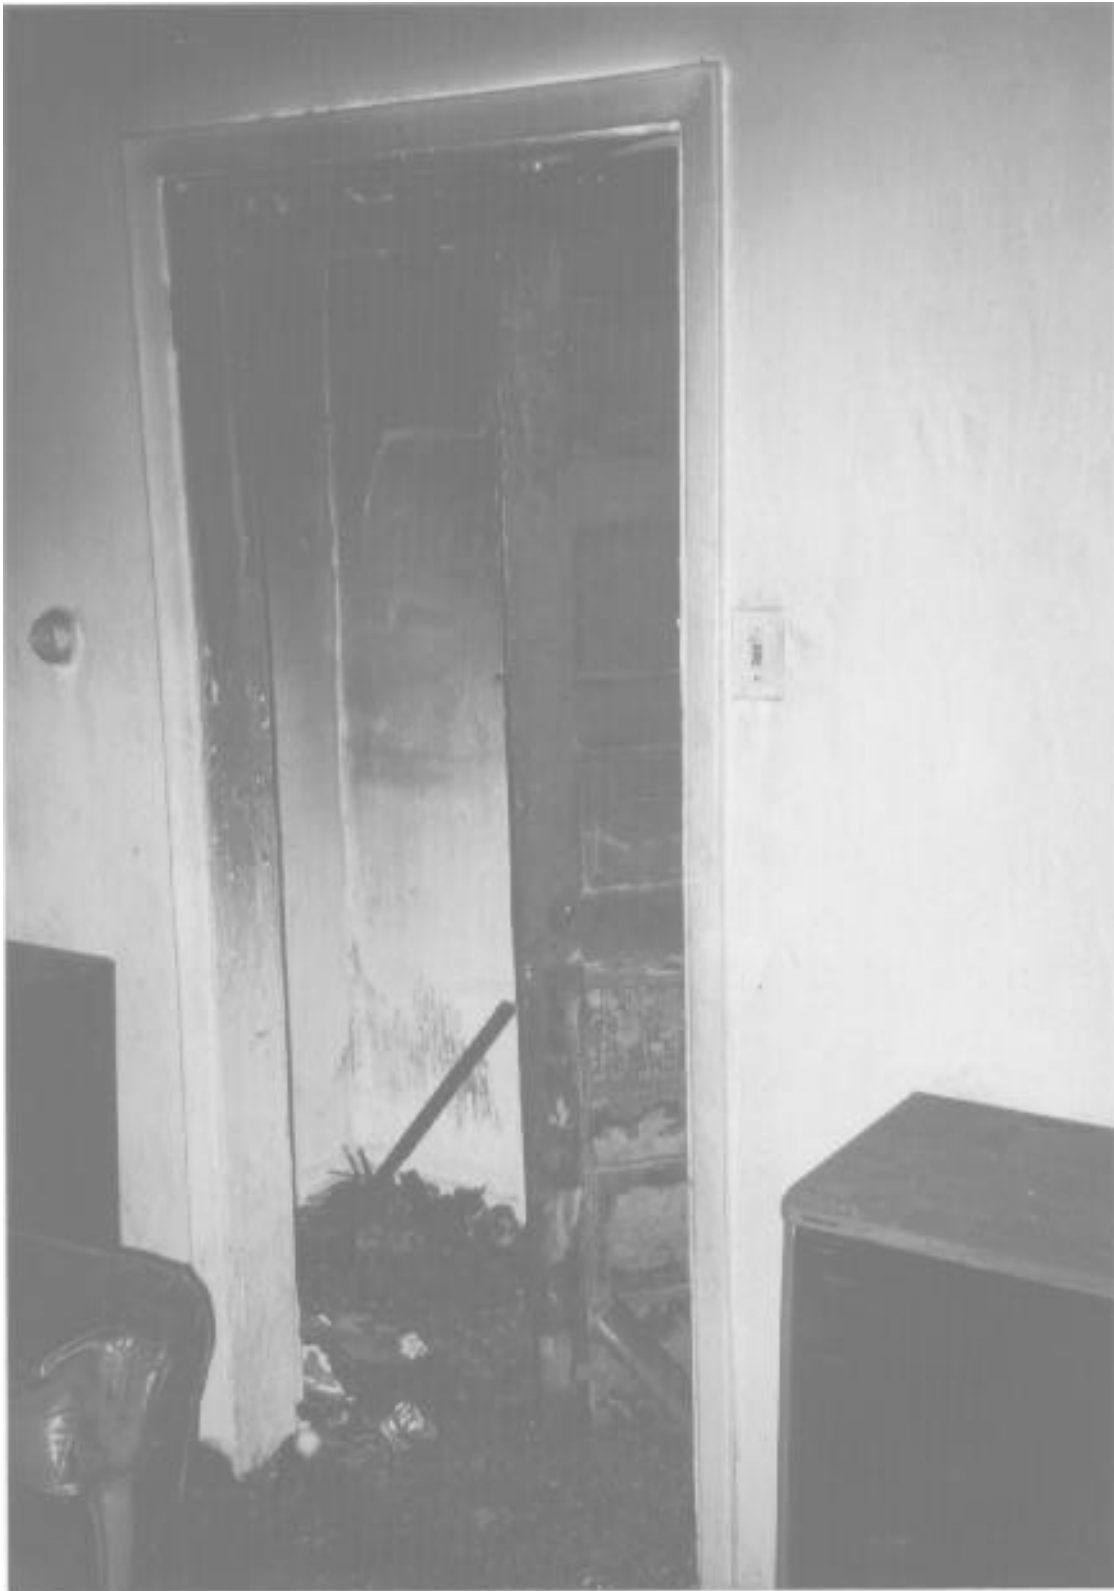
View from family room looking toward kitchen. Partially open door is at the top of the basement stairs.

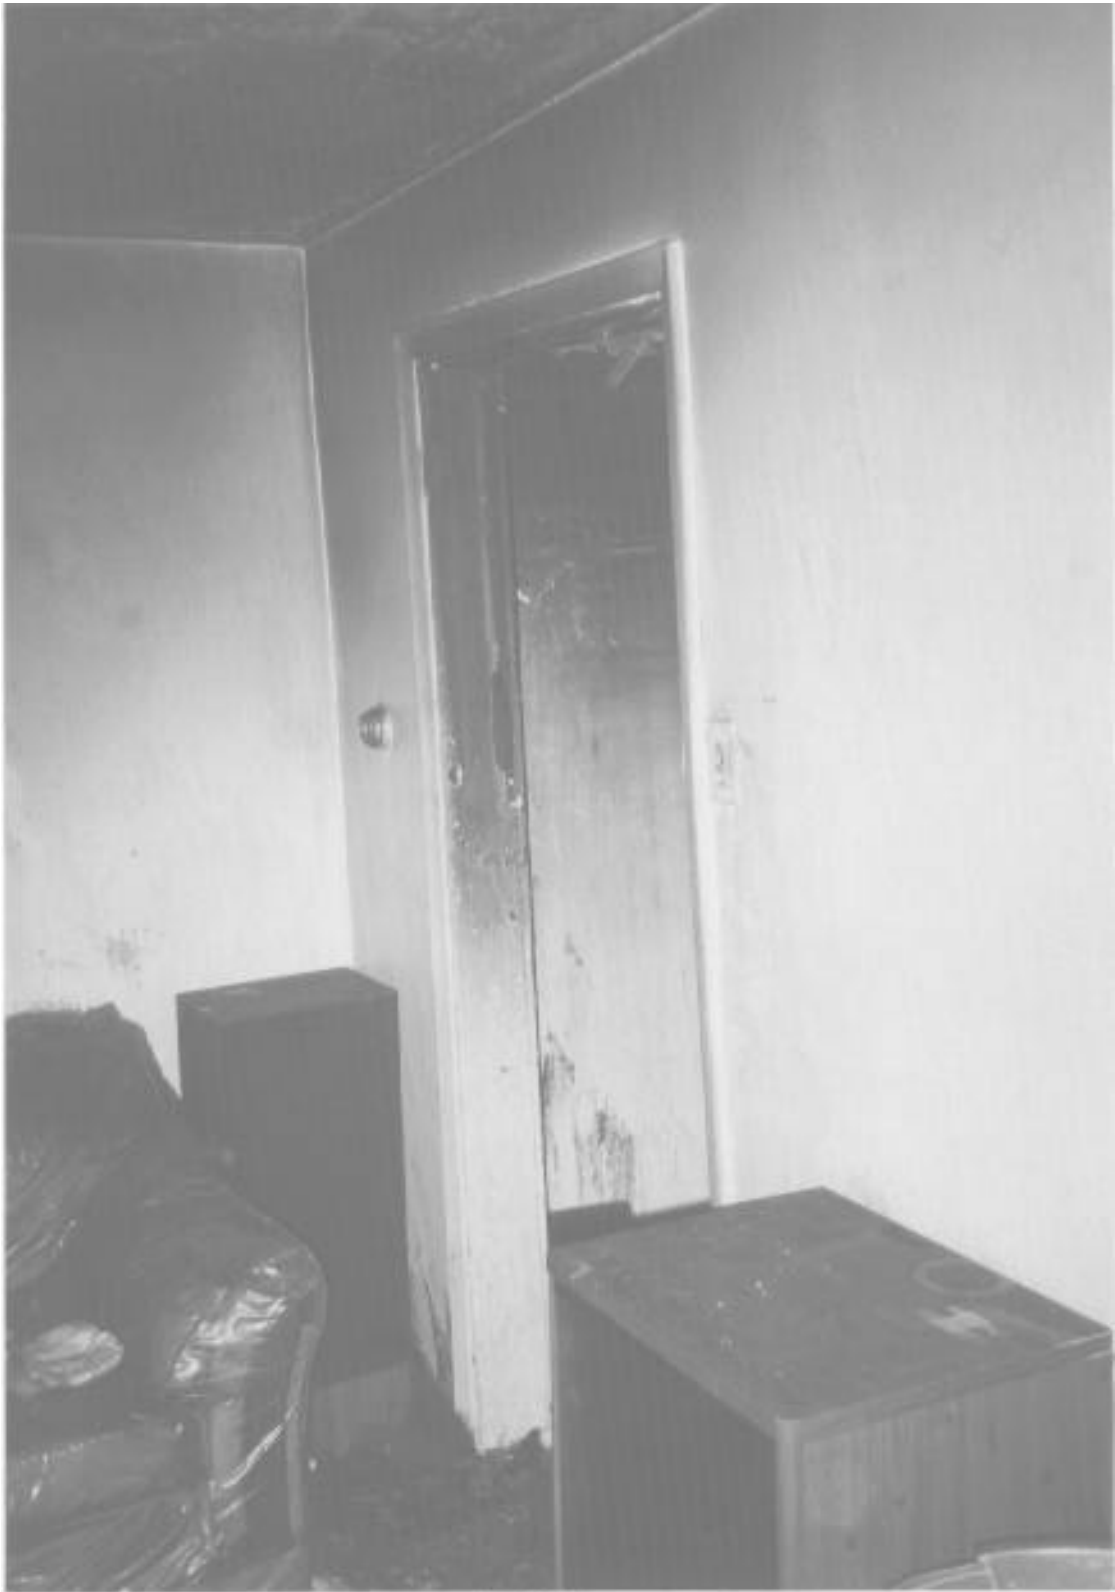
View of corner of the family room at top of basement stairs.
